(A) TYPICAL CRIPPLE WALL BRACING DETAIL

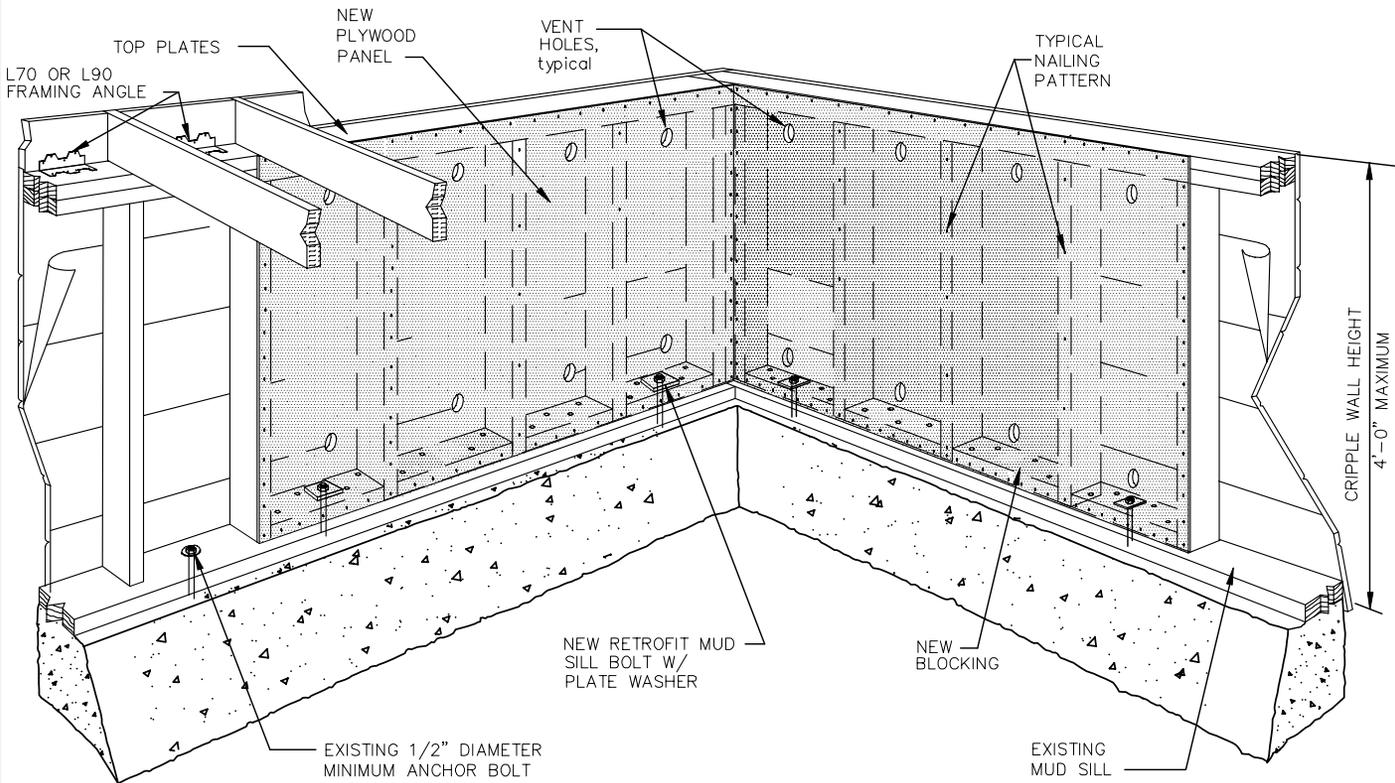
1. THIS DETAIL SHOWS A SAMPLE CRIPPLE WALL WHICH HAS UNDERGONE A TYPICAL SEISMIC STRENGTHENING.
2. THIS DETAIL IS NOT INTENDED TO SUPERSEDE REQUIREMENTS CONTAINED IN THE SPECIFIC INSTALLATION DETAILS ON SHEET 2 OR THE PLAN SET BOOKLET.
